This letter contains important information about your **Laerdal Compact Suction Unit® 4 (LCSU® 4)**. Please read this letter and the attached Urgent Field Safety Notice.

Urgent Field Safety Notice 2016-R-04

Laerdal Compact Suction Unit® 4 (LCSU® 4) cannot be turned off, or turns on by itself.

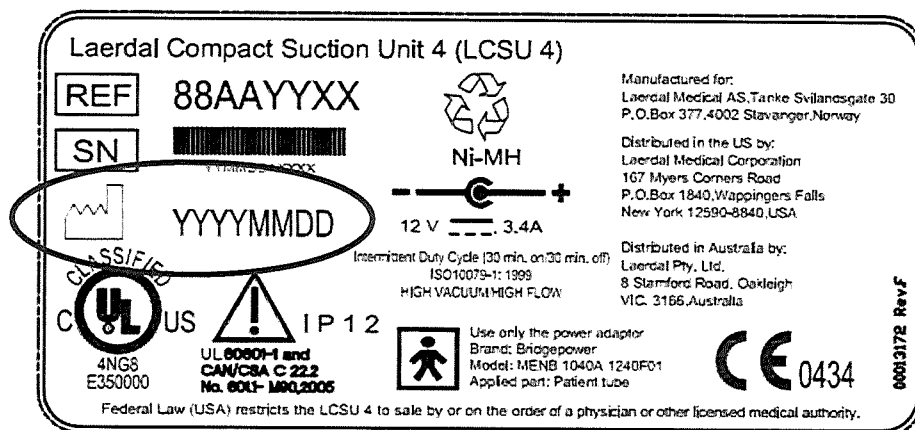
This Urgent Field Safety Notice covers all LCSU 4 units manufactured from 1 May 2015. The LCSU 4 units are labelled with Manufacturing Date in the format YYYYMMDD (year - month- day).

Affected units are labelled with Manufacturing Dates in the range 20150501 to 20161028.

The Manufacturing Date can be found on the label on bottom of the LCSU 4 as shown below:

Exception: Some LCSU 4 units have a 'RW' label on the bottom. These units have been reworked by Laerdal Medical and are not affected by this Field Safety Notice, even if they have manufacturing dates within the 20150501 to 20161028 range.
